## **A320 Hoe Stream Bridge**

### **Project Detail**

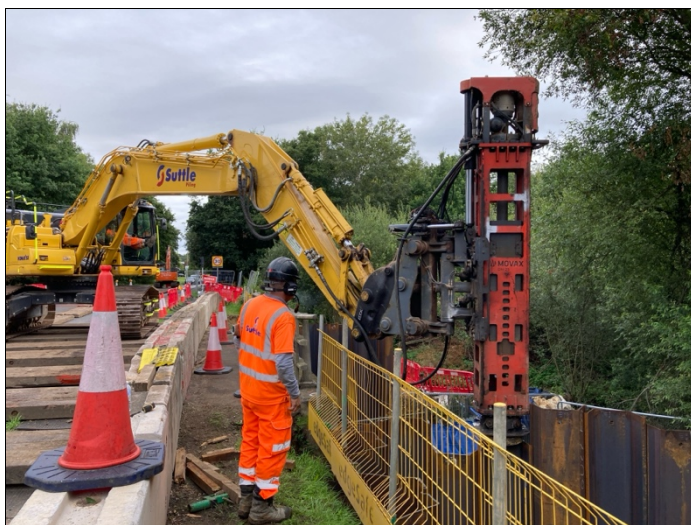
Figure 1: Back driving piles using DH25 attachment

Using our simplified approach, we overcame each challenge efficiently and effectively. We selected our Komatsu PC490 with Movax attachments SG75v and DH25, the Komatsu has a great reach of 9-10m which easily achieved the reach required for the piling location. To ensure the gas pipe was uninterrupted we completed a platform design to ensure the ground loadings from our Komatsu PC490 would not impact the gas pipe in any way.

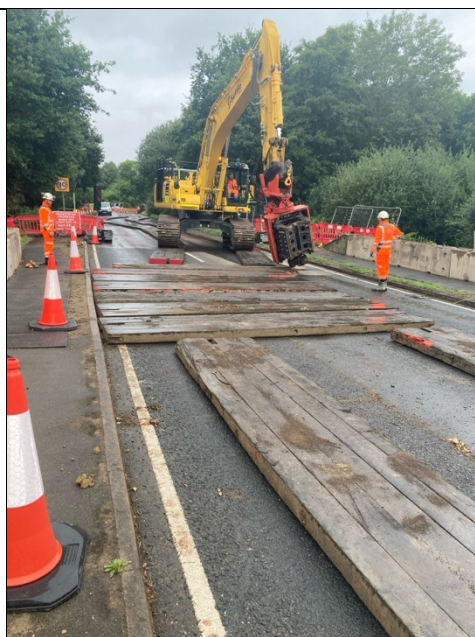
Figure 2: Bog mats laid out to avoid damage to the road

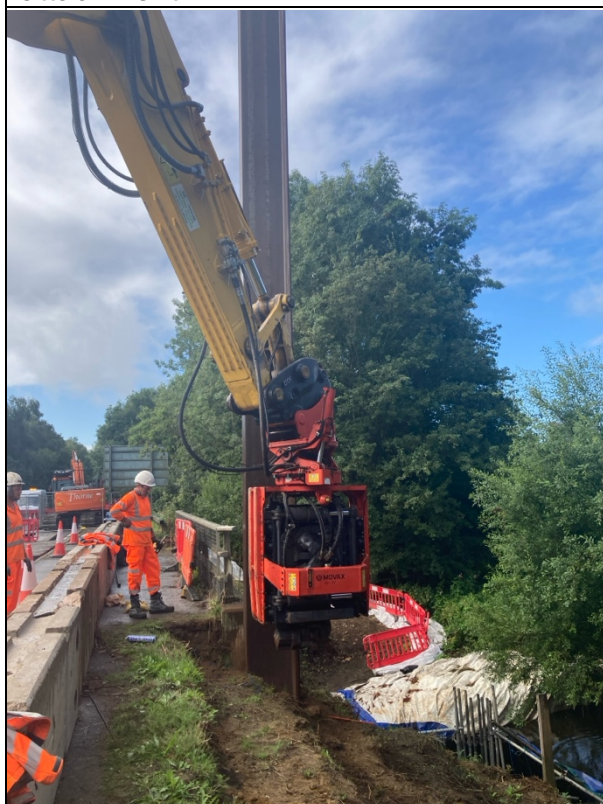
Figure 3: Installing sheet piles using SG75v attachment

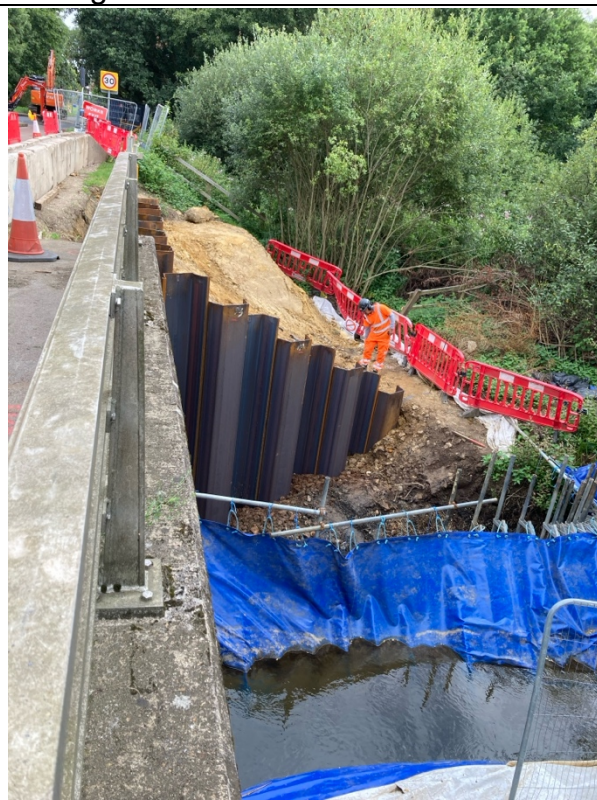
Figure 4: Installed sheet piles

The Hoe Stream bridge had previously been stabilised by a gabion basket retaining wall situated at each corner of the bridge. Over time the gabion baskets have suffered excessive movement and failed in the north-east corner. As a more long-term solution, Suttle Projects were instructed to install a sheet pile retaining wall to replace the gabion baskets in each corner.
