# Stokes Bay East Seawall Replacement

## Coastal Protection Scheme

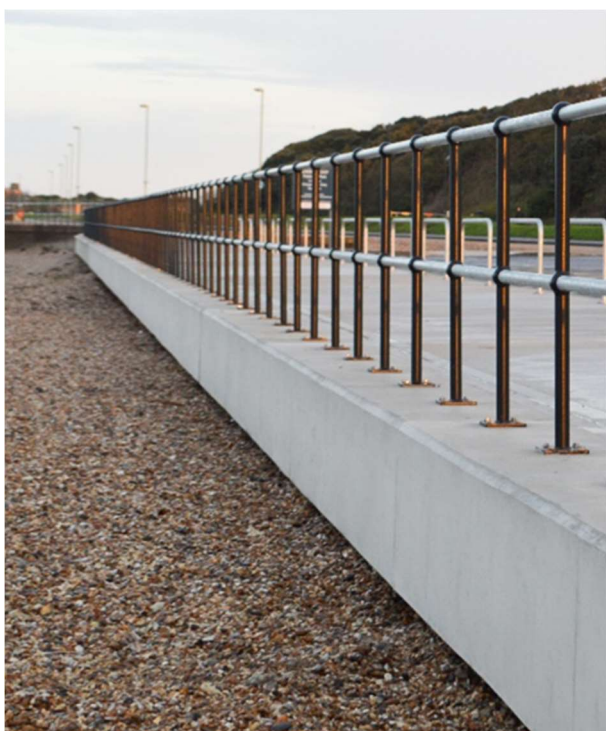
A new reinforced concrete capping beam was constructed on top of the piles to create the new seawall. This was achieved using Dawson soffit formwork, which is easily installed onto the sheet piles, providing a programme benefit compared to conventional formwork. The system was designed to ensure no grout was lost into the sensitive marine environment. Stainless tying wire was utilised for all steel fixing, and concrete with XS3 exposure class (a mix with a low carbon cement alternative) was used to ensure the required design life in the coastal environment.
