# Poole Bay Coastal Defence Scheme

## Prevention of longshore drift

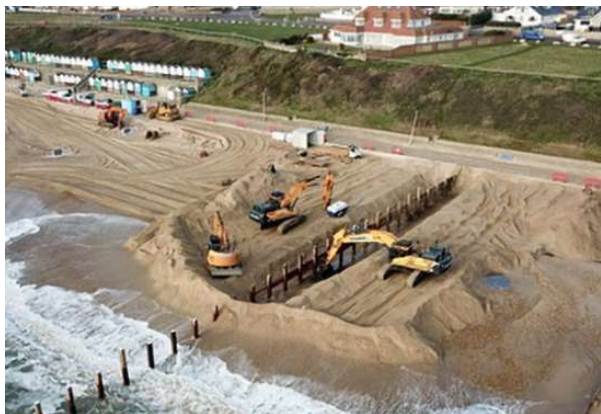
Each groyne is between 5.0 and 7.5m deep and approximately 75 metres in length. They consist of 10 metre long timber piles spaced 2.5 metres apart, with a 12.5 metre king pile located out at sea. The piles are connected with 17 rows of bolted timber planking, with each groyne requiring approximately 225 planks.

The process of installing the piles was carefully developed to avoid causing any later deflection along the line. This commenced with the location being marked out using a robotic total station to ensure accurate dimensional control. Our Leader Mounted Auger was then used to drill to the required depth, loosening the natural soil to allow the piles to be driven into position using our Movax vibratory pile driving attachment mounted on a 35-tonne excavator.

The timber planking was assembled using a 24-tonne excavator with fork attachments to minimise manual handling. Heavy duty pneumatic hand tooling was used to fix the tropical hardwood together with marine grade fixings. Where the planks were required to be installed deeper into the beach, heavy excavators were deployed to excavate along the line of the piles.

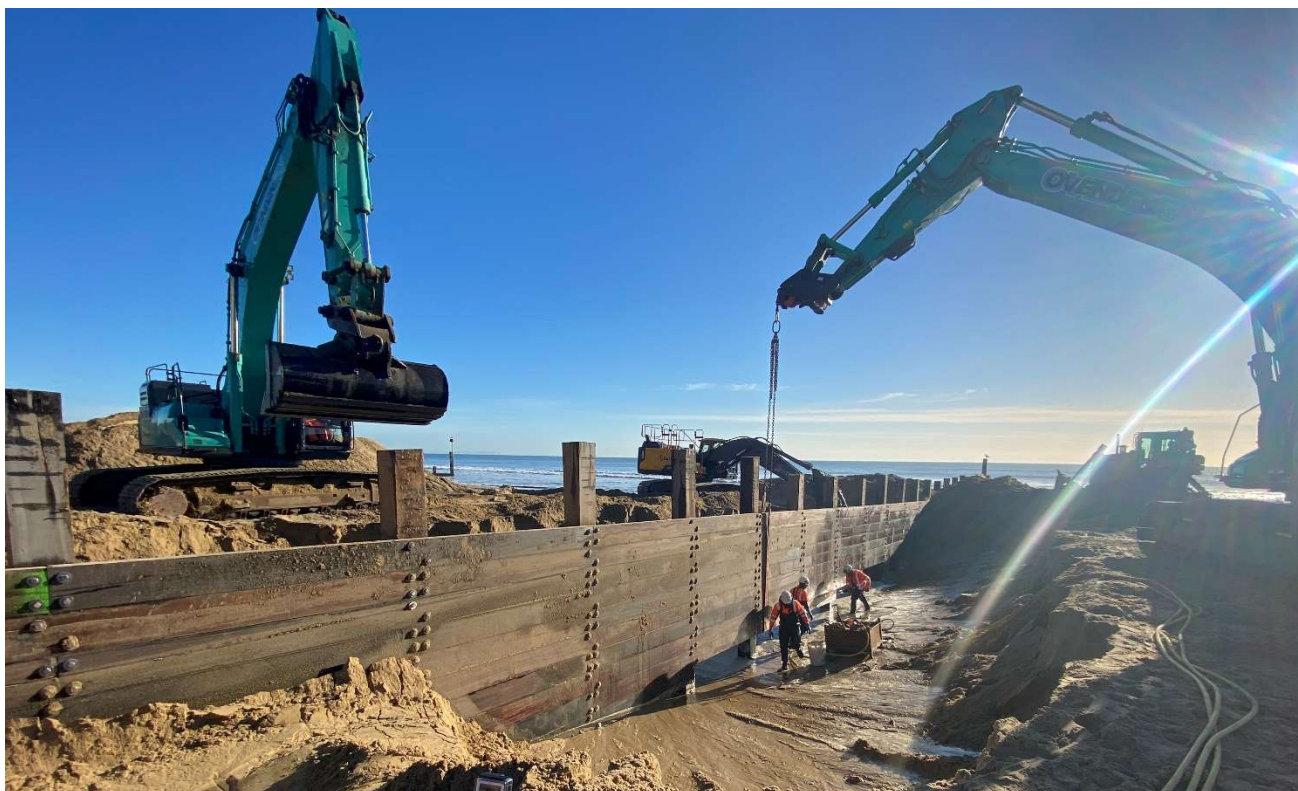
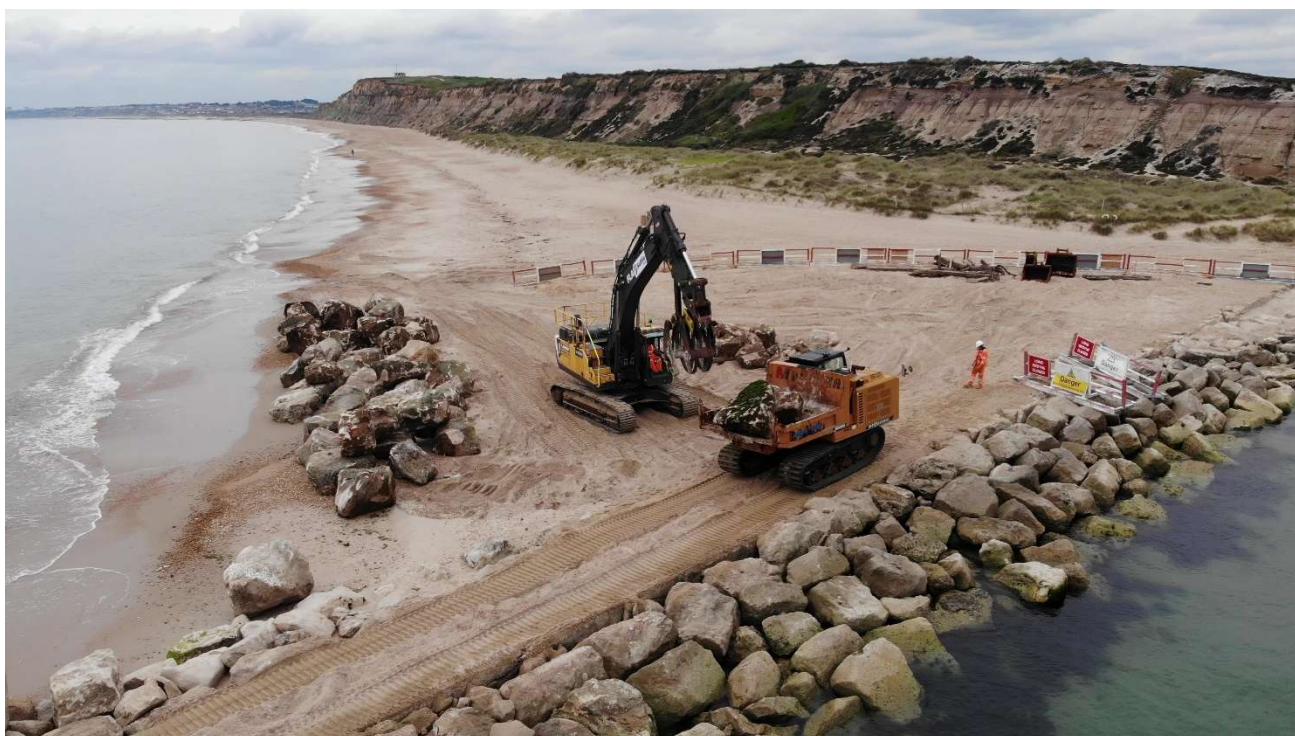
The 150 metre long voided concrete and rock groyne, was understood to be at risk of serious deterioration in the middle of the structure, requiring a detailed survey to establish the extent of the potential damage.

In order to inspect the core of the structure, the protective rocks surrounding it had to be removed. Great care had to be taken to avoid disturbing the groyne itself and risk causing further damage to the concrete structure.

Once the concrete structure was exposed, we assisted our supply chain in undertaking the high-definition subsea survey. This was undertaken using sonar and laser technology to create a 3-dimensional visualisation that revealed the groyne to be in poor condition.

The sequence of rock removal and reinstatement was meticulously planned with BCP's coastal engineer to ensure that the concrete structure would not be excessively exposed to wave action whilst unprotected by its rock armour.

The investigatory work gave BCP the necessary information to design a major strengthening scheme to increase the resilience of the groyne structure which will protect the coastline from sea level rise over the next 100 years.
